Incident Report

No. IR210001 August 5, 2010

Transocean Crane Load Testing Causes Catastrophic Failure

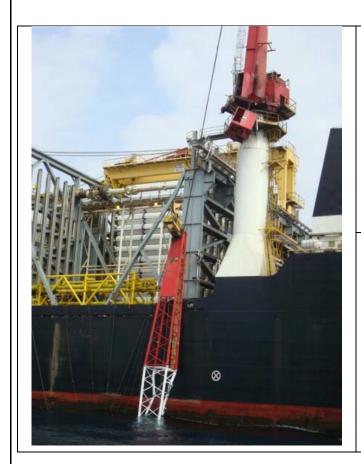
During a crane load test on the Transocean drillship Jack Ryan, using water bags for the load, the crane boom dislodged from the crane upper works. The crane boom came to rest behind the crane in the sea below the drillship. The boom suspension still held the tip section of the boom to the crane. The water bags and the complete boom assembly rested alongside the hull of the ship in the sea below the vessel.

The crane boom impact to the crane cab caused the crane cab to dislodge from the upper works, allowing the operator and another person to be thrown from the crane cab to the sea below.

A history of poor maintenance of the crane allowed for boom heel pin to upper works connection to degrade into an unsafe condition. The boom heel pin bushings were no longer in place, which caused significant wear to the boom heel pins and massive elongation of the boom heel section connection holes. The total amount of wear allowed for movement of the boom tip of eight feet in a side-to-side direction.

The poor maintenance of the boom to upper works connection allowed for a massive side load to be introduced to the crane boom. In addition to the status of the poor connection, the vessel motions induced by the movement of the test load caused the heel pin to upper works connection to fail.

A pre-load test inspection, had one been performed, would have identified these deficiencies.

Perform routine maintenance as described in operations and maintenance manuals which is in accordance with inspection and maintenance criteria outlined in API RP 2D.

When performing a load test, a pre-load test inspection and a post-load test inspection should be performed as described by regulatory recommendations.

A certified calibrated dynometer should be used when using water bags for load testing to determine the weight of water bags.
