GOMR Incident Trends

Jason P. Mathews

Chief, Office of Safety Management
Gulf of Mexico Region

June 7, 2022

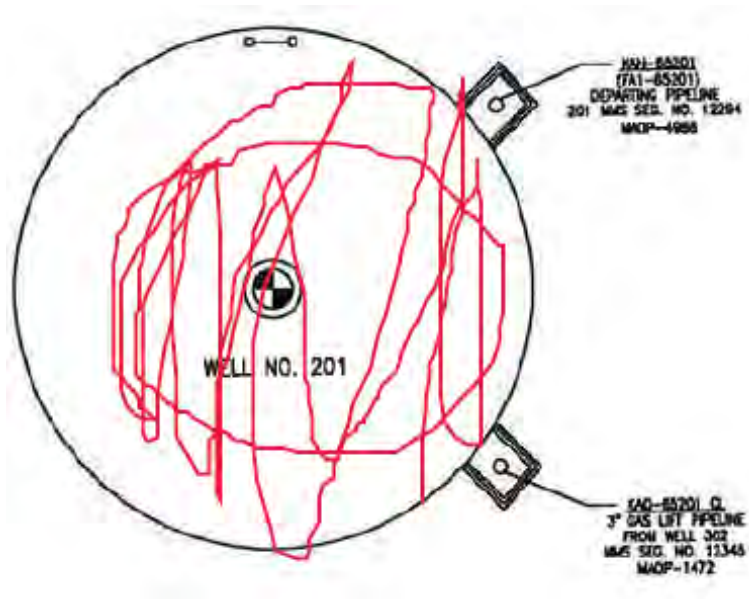
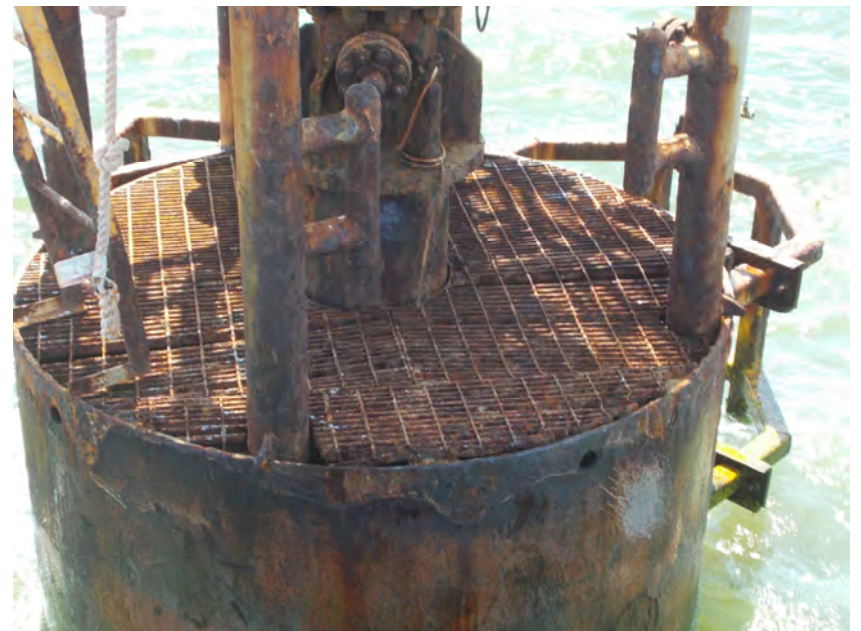
Corrosion INCs

- Grating/supports on boat landing

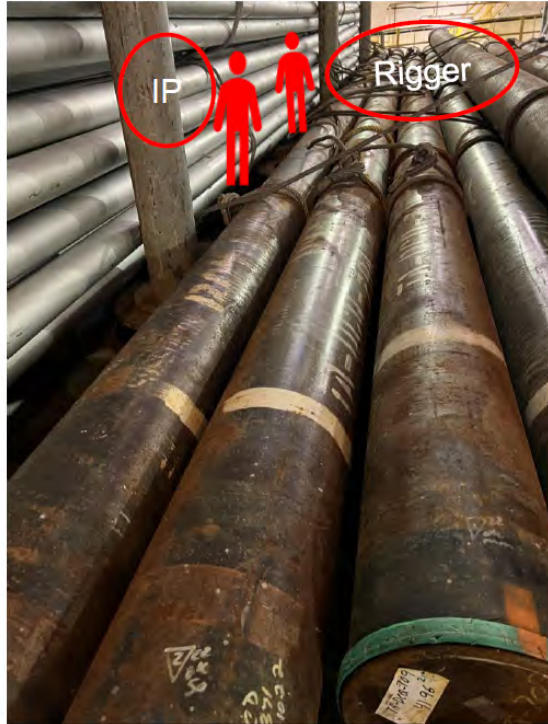
- Rigger: Preparing to hook slings to crane
- IP: Location at time of incident

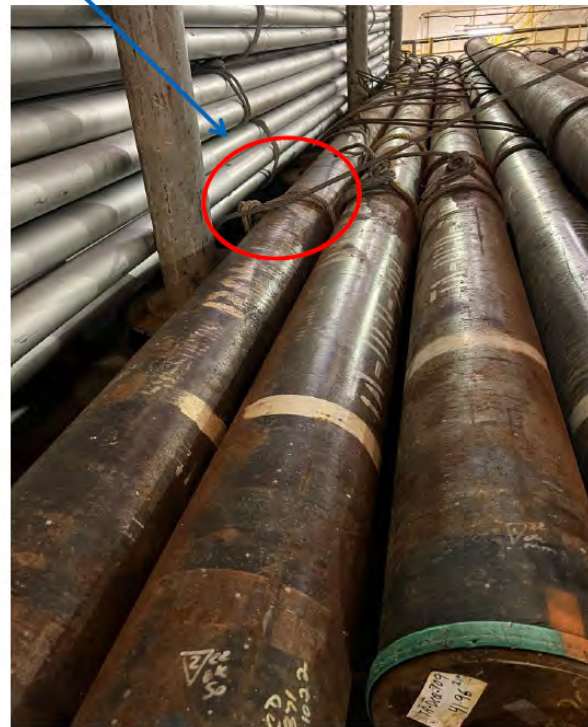
- Sling being hooked to crane is looped around dog clamp of another sling.

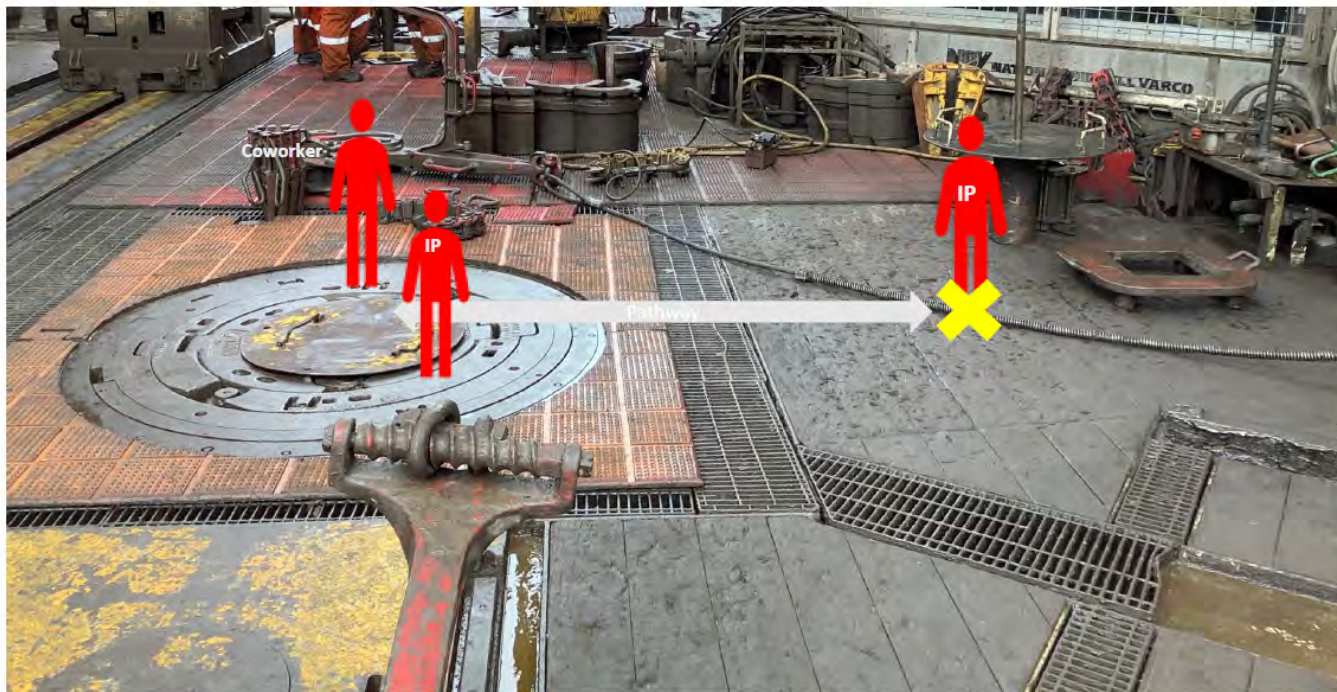
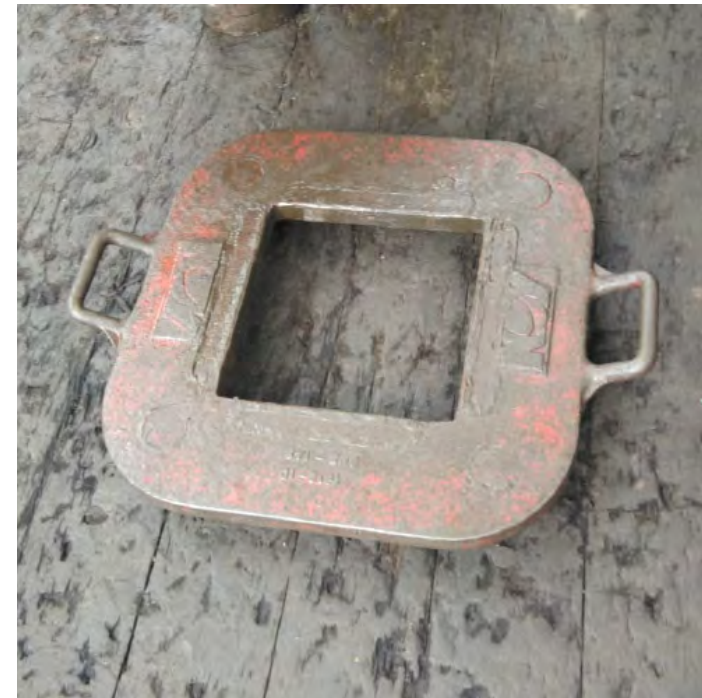
Injury - 3/14/2022 – RW-JT >3

- Area of IP and Coworker at the start of carrying the Bit Breaker to the setback area

- IP Location at time of incident tripped over the tong pull line.

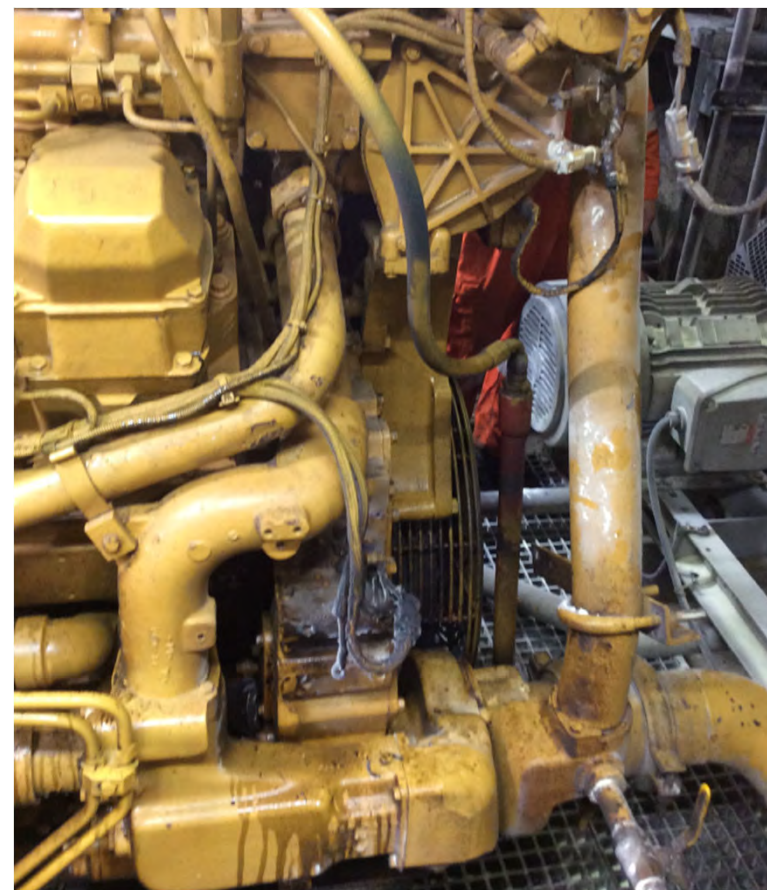
Fire – 3/3/22

- 03:10 am, fire in the #3 generator engine room. The fire was contained to the room.
- Generator #3 engine threw a rod, causing oil to spray from engine, coming into contact with a hot surface, which ignited the fire.
- Fire alarm was sounded immediately, rig secured the well, and the platform ESD was activated.
- The crew fought the fire for 5 - 7 minutes. 14 fire extinguishers were brought to the scene, personnel used 11 to extinguish the fire.
- Fire spread to a stack of air filters which were difficult to extinguish.
- 03:23 am - the fire was extinguished

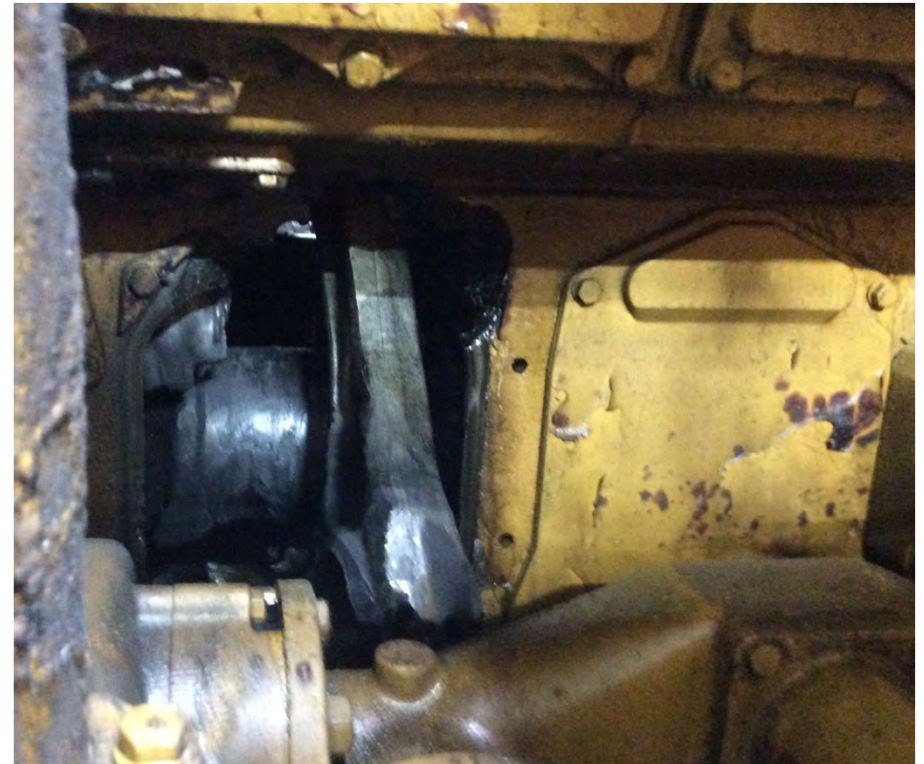
Fire – 3/3/22, continued

- Motorhand couldn't stop the engine from the engine room control panel, had to stop it from the VFD house.
- Lesson learned – don't store flammable materials (e.g. air filters) in engine room.
- No indication why the engine failed at that specific time. Engine had been serviced the previous day and no problems were noted.
- No evidence of deficient maintenance.

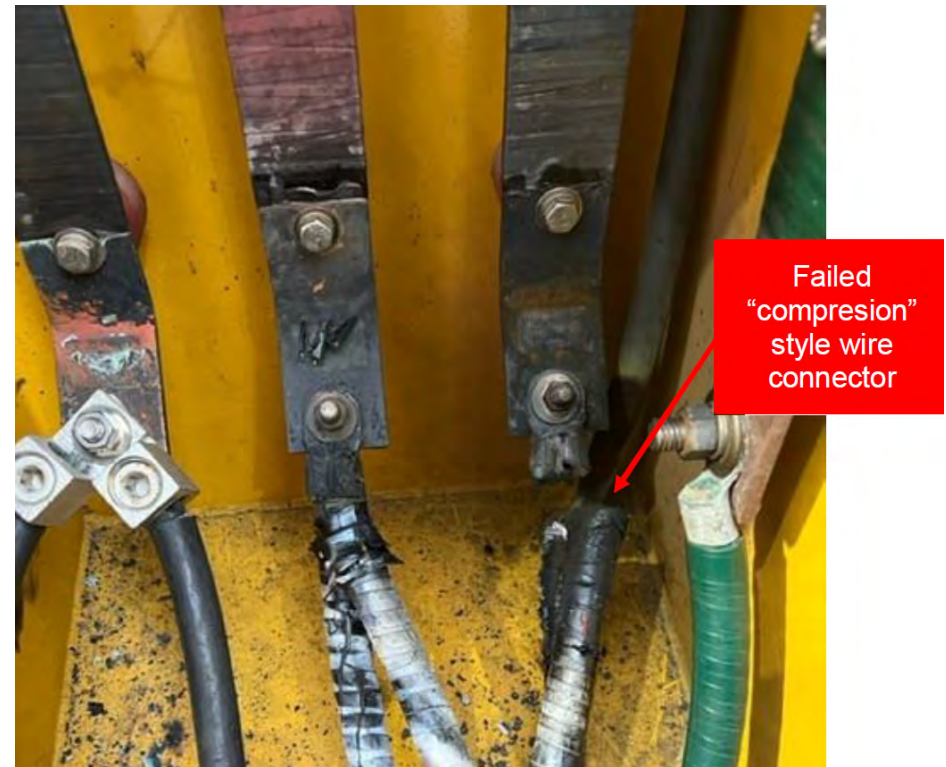
Fire – 3/9/22

- The lights in the living quarters began to flicker. The smoke alarm for the 3rd floor living quarters went into alarm status. Personnel responded and located an air handling fan motor that was smoking due to the variable voltage feed from the rental generator. The fan motor was disconnected and secured. The PIC immediately responded to the MCC and noticed that the rental generator was only producing 200V.
- Personnel opened the breaker for the rental generator, disconnecting power to the platform.

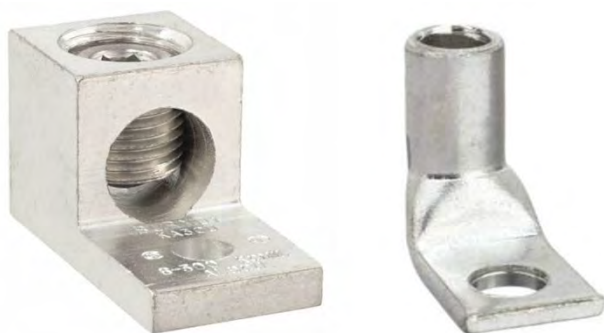
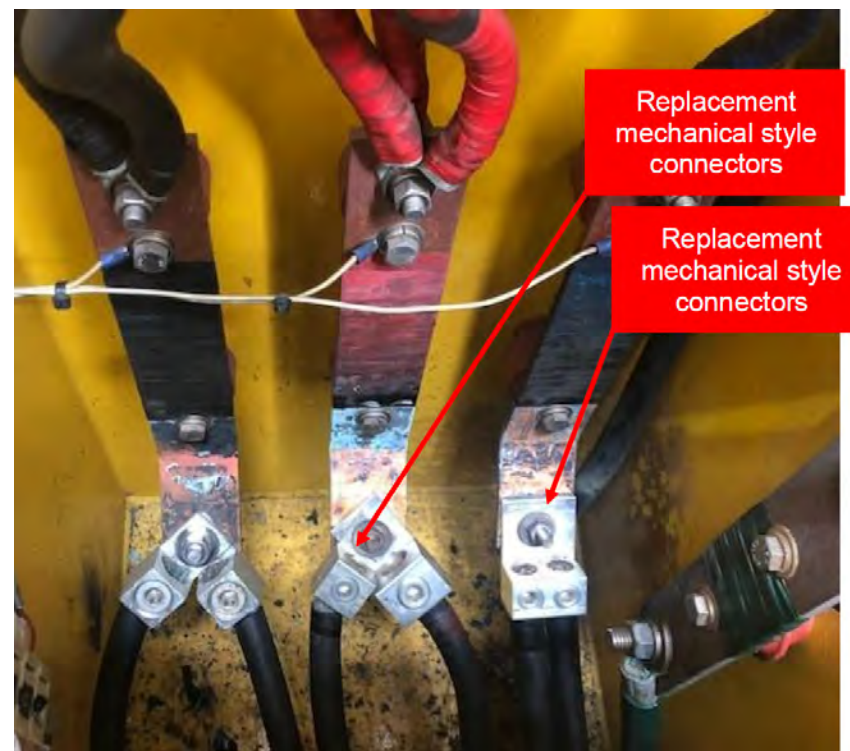
Fire – 3/9/22, continued

- Initial indications found that the cause of the incident was due to one of the cable leads failing at the terminal connection.
- Phase failure can cause motors to overheat.
- The electrician on board installed new mechanical connections to mitigate the issue and prevent reoccurrence.

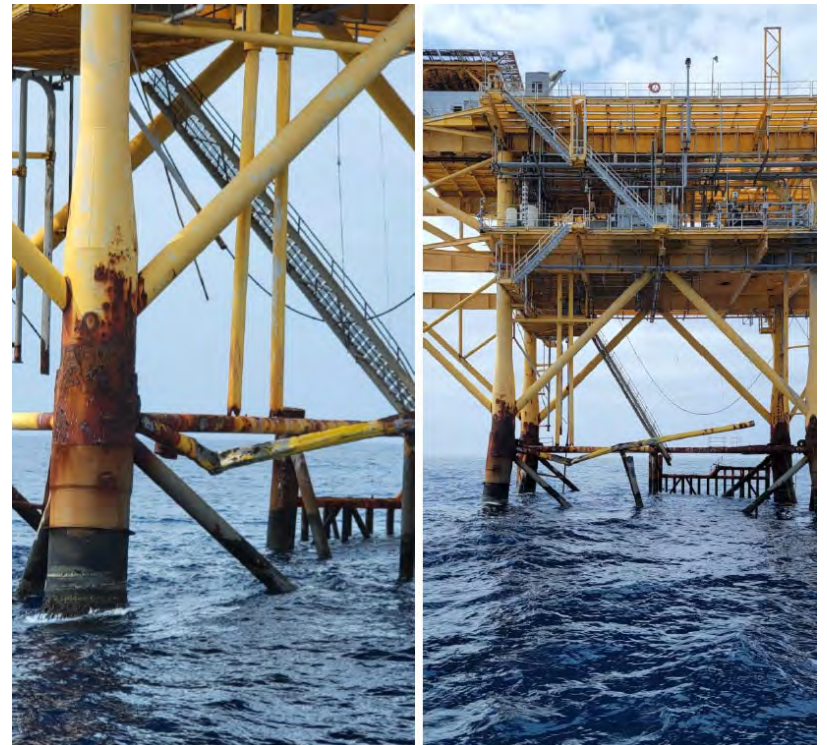
Collision – 3/7/22

- Facility was struck by a M/V during the night.
 - Unmanned and out of service facility. All wells P/A'd, waiting to be permanently removed.
 - Operator notified the USCG of a non-functioning navigational aid on 7/8/21.

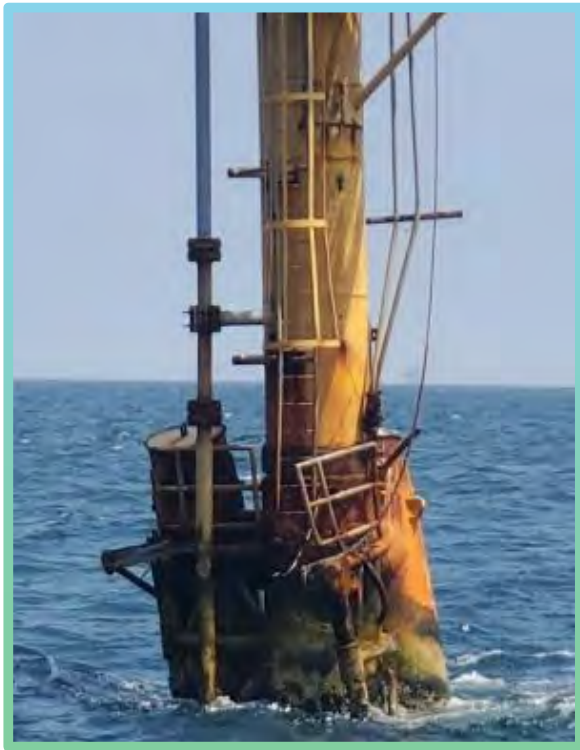
Collision – 4/18/22

Operators were utilizing a field boat to make the visit; upon arrival they found the boat landing was missing from the facility.

There was evidence that showed a probably vessel strike to the landing area.

Foghorn and Nav-Aid lights were verified to be working upon arrival. There was no evidence of any pollution.

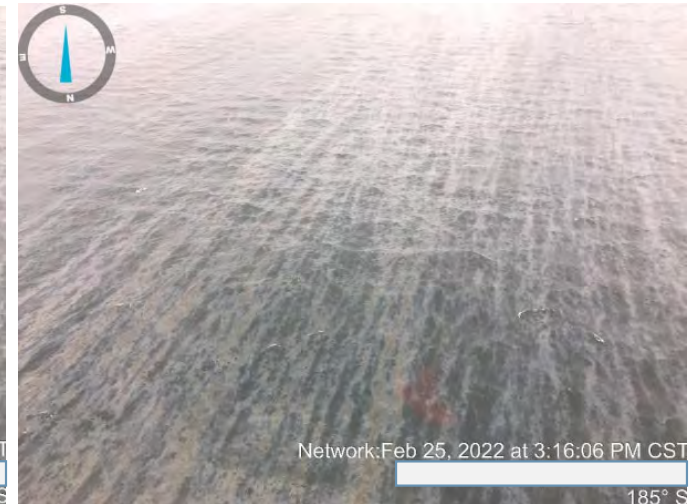
Spill >1 bbl – 2/25/22

- An estimate of 111 gallons of unrecoverable oil was discharged into the Gulf of Mexico through the platform's vent boom.

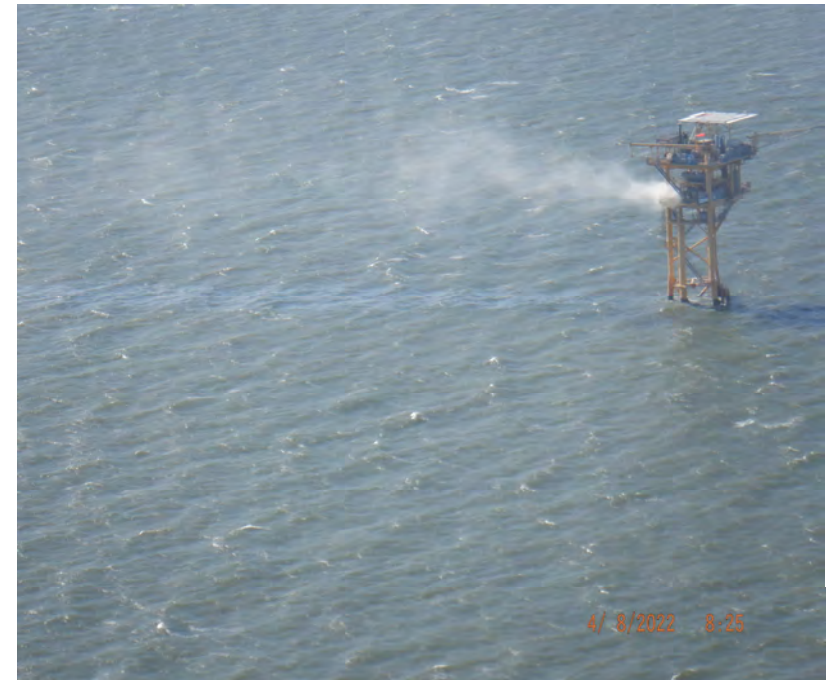
Gas Release - 4/8/22

- Sheen was visually observed from aircraft while in transit to another location. Sheen spanned 30-50 ft at the base of the facility stretching ~4500ft southeast.
- Large gas cloud
- Loop operators landed a few minutes later, took photos and stopped the leak via ESD on helideck.

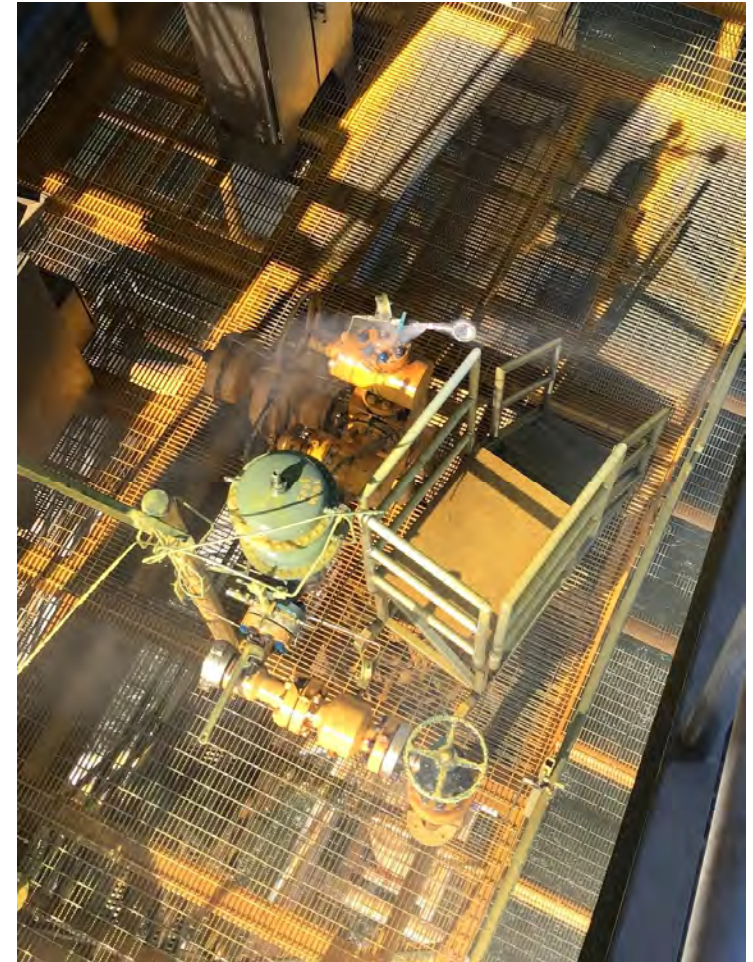
Gas Release - 4/8/22, ctd

- Leak caused by damaged quick connect tubing fitting
- Operator was/is in the process of installing remote shut in SCADA upgrade.
- Operator was initially alerted to the leak via radio chatter in Breton Sound area.
- Unclear when the leak started.
