Aviation Investigation Preliminary Report

Location:	Galliano, LA	Accident Number:	CEN23FA071
Date & Time:	December 29, 2022, Local	Registration:	N595RL
Aircraft:	Bell 407	Injuries:	4 Fatal
Flight Conducted Under:	Part 135: Air taxi & commuter - Non-scheduled

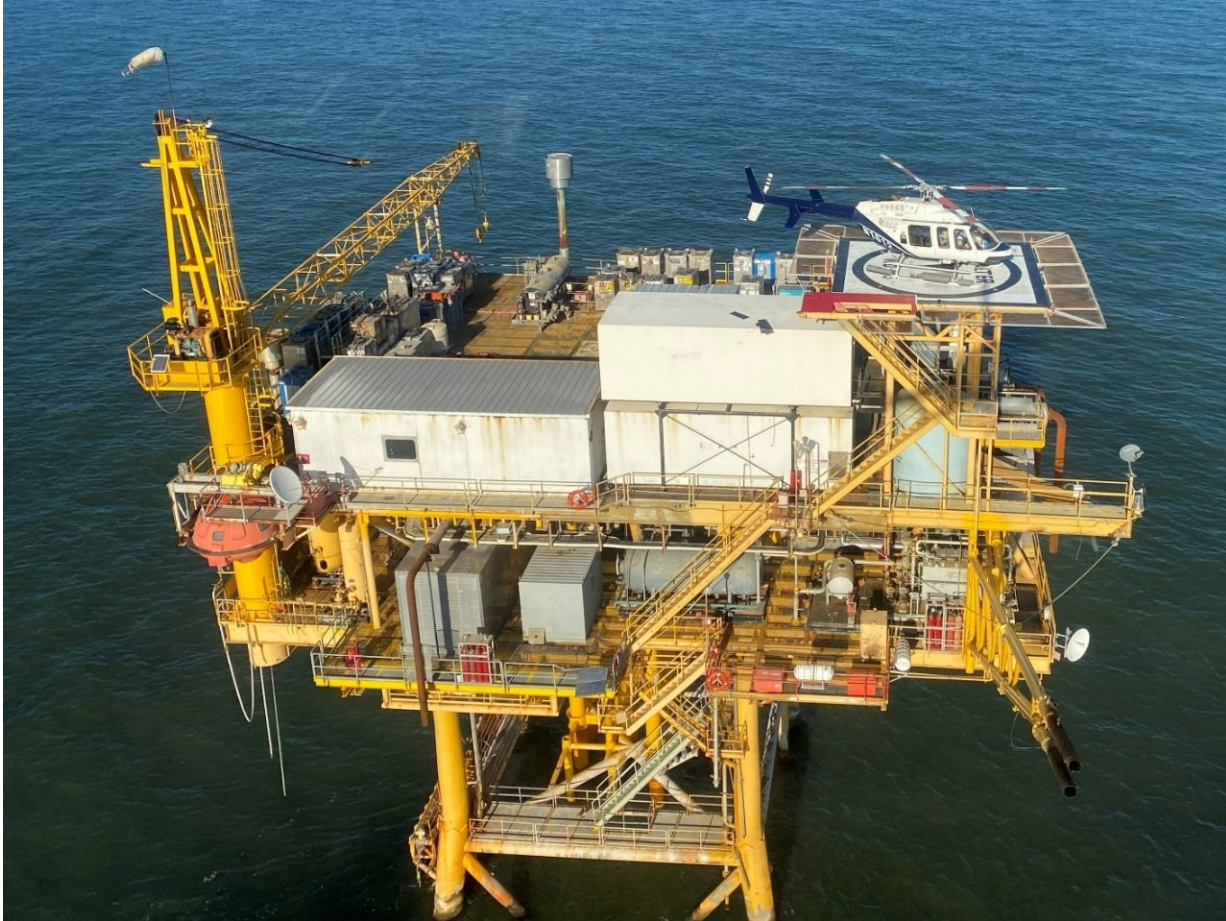
The WD106 platform is equipped with a 24 ft by 24 ft helipad, as shown in Image 1. The helipad was constructed of recently repainted metal and was surrounded with a chain link

Image 1 – Overview photo of West Delta 106 platform with exemplar Bell 407 helicopter on the helipad. The helicopter is facing southeast on the helipad. The damaged chain link perimeter skirt on the southwest side of the helipad was removed after the accident.

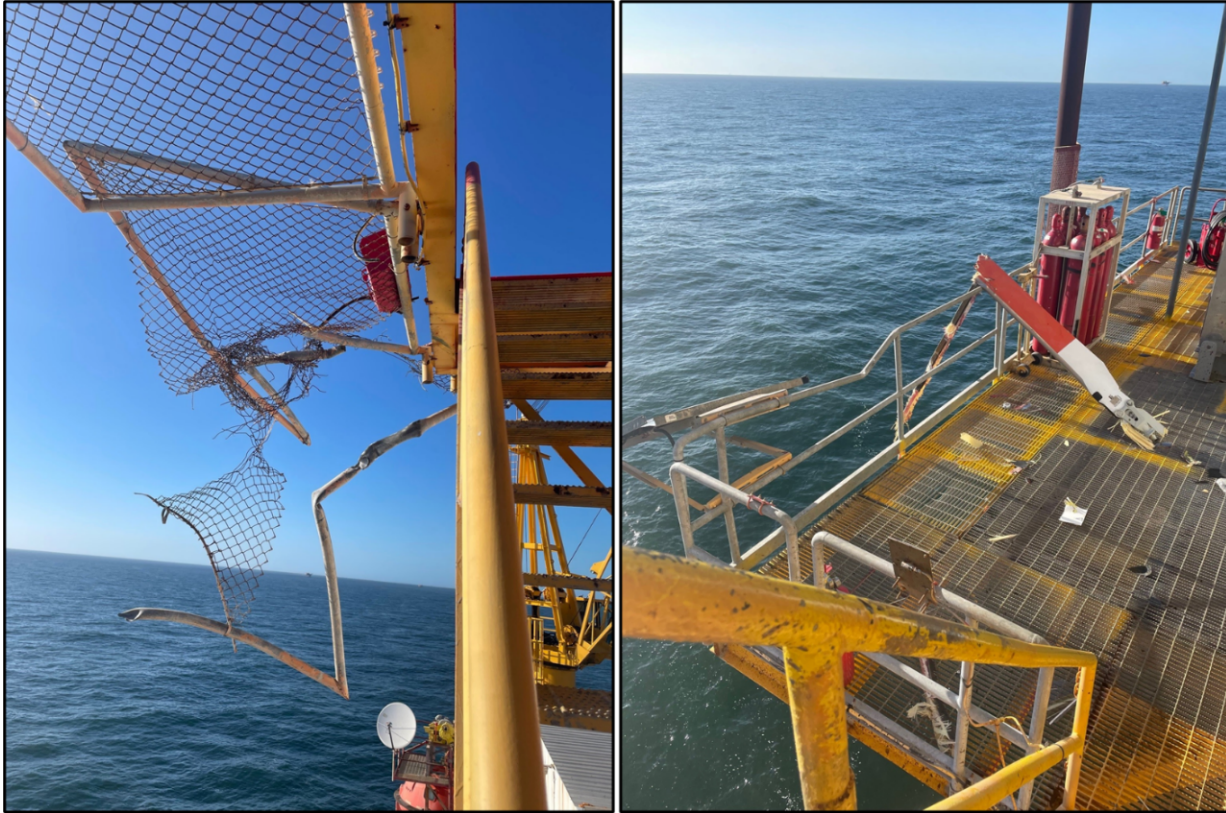
Examination of the helipad revealed the red paint of the stairwell was gouged and scratched near the southwest end, nearest the skirted area. The skirt near the stairwell was damaged with metal posts bent and broken and the skirt wire damaged and torn, as shown in Image 2a. One perimeter light, on the southwest corner separated from the helipad and was not recovered. An adjacent perimeter light, located at the center of the west edge of the helipad, was damaged and separated from the helipad, as shown in Image 3a. The light's blue glass globe was shattered, and shards were found on the deck below the helipad. The remaining perimeter lights appeared undamaged. There were two areas of the landing pad surface with gouges in the paint. One area was located on the western area of the aiming circle and consisted of 3 linear gouges and 2 circular gouges into the paint. The other area consisted of 9 linear gouges in the paint.

Further examination of the platform revealed composite debris scattered throughout multiple decks below the helipad. Most of the scattered debris was consistent with the materials used to construct the main rotor blades. A six-foot-long portion of a main rotor blade came to rest on a metal handrail located on the deck below the helipad, as shown in Image 2b. The handrail exhibited a downward bend near the location of the main rotor blade. Three pieces of lead weight, consistent with blade weights, and multiple pieces of dark tinted acrylic, consistent with the cockpit overhead windows from the helicopter, were found on the same platform deck as the main rotor blade. The acrylic shards exhibited red paint transfer consistent in color with the red paint of the stairwell. The upper hydraulic servo cover, normally located above the cockpit, also exhibited the same red paint transfer, as shown in Image 3b. Fragments of tail rotor blades were found on the deck below the helipad. There was impact damage to the left landing skid-to-aft crosstube interface.

Image 2a (left) – Damaged chain link perimeter skirt on southwest corner of helipad
Image 2b (right) – Portion of a main rotor blade found on the deck below the helipad

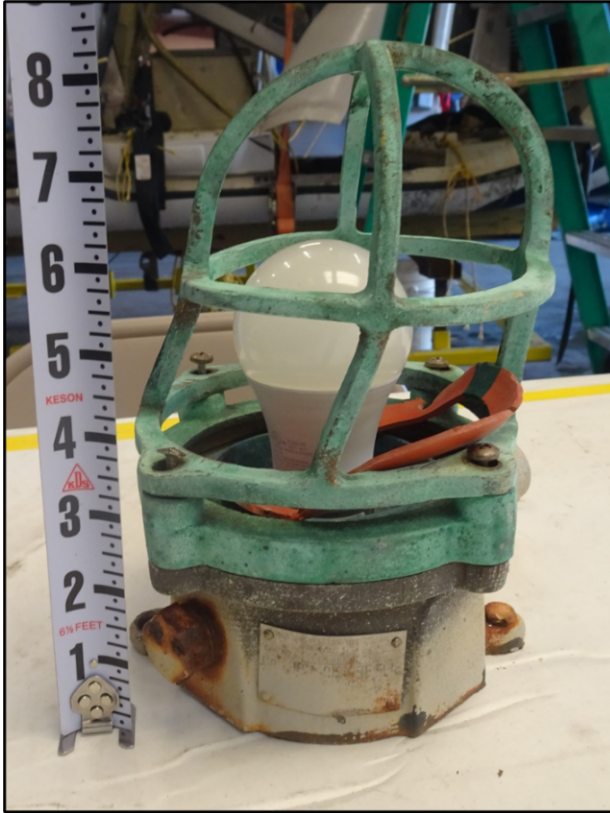
Image 3a (left) – Damaged perimeter light from west edge of helipad

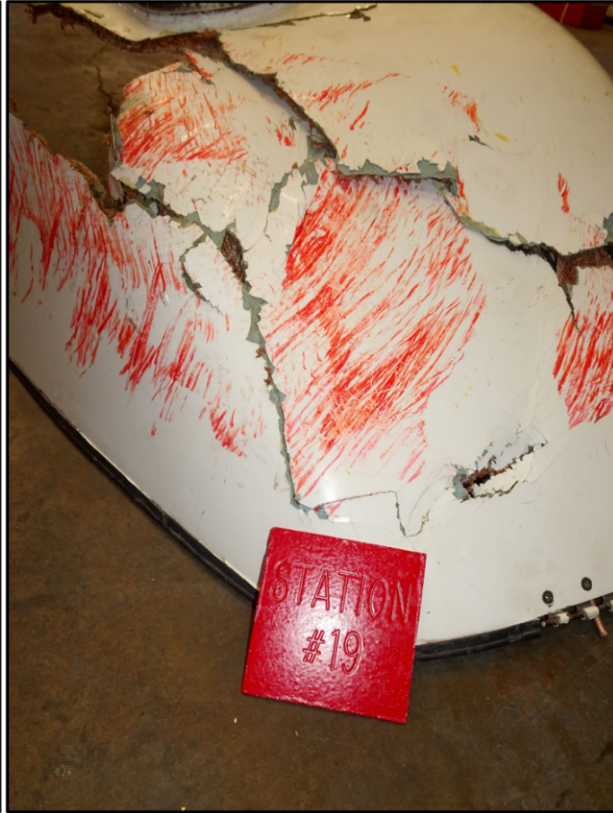
Image 3b (right) – Upper hydraulic servo cover with red paint transfer and exemplar paint sample from platform.
