INCIDENT TRENDS – 2023Q2

OCS - GULF OF MEXICO

RFO - Office of Safety Management

24 August 2023

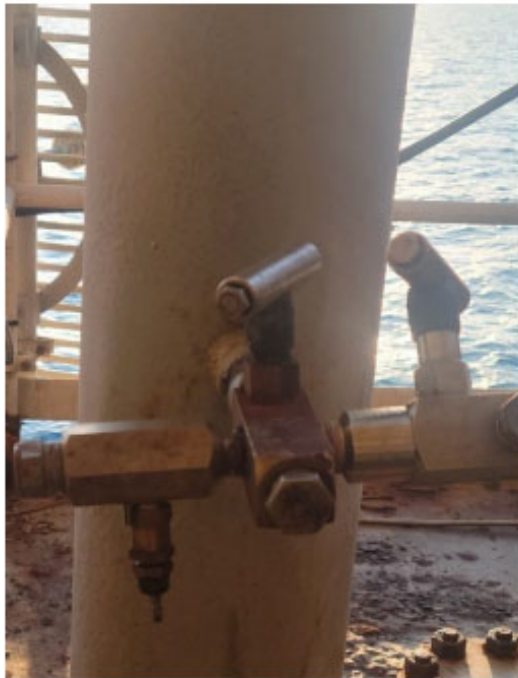
HIPO NEAR MISS – 7/3/2023

Valve Assembly

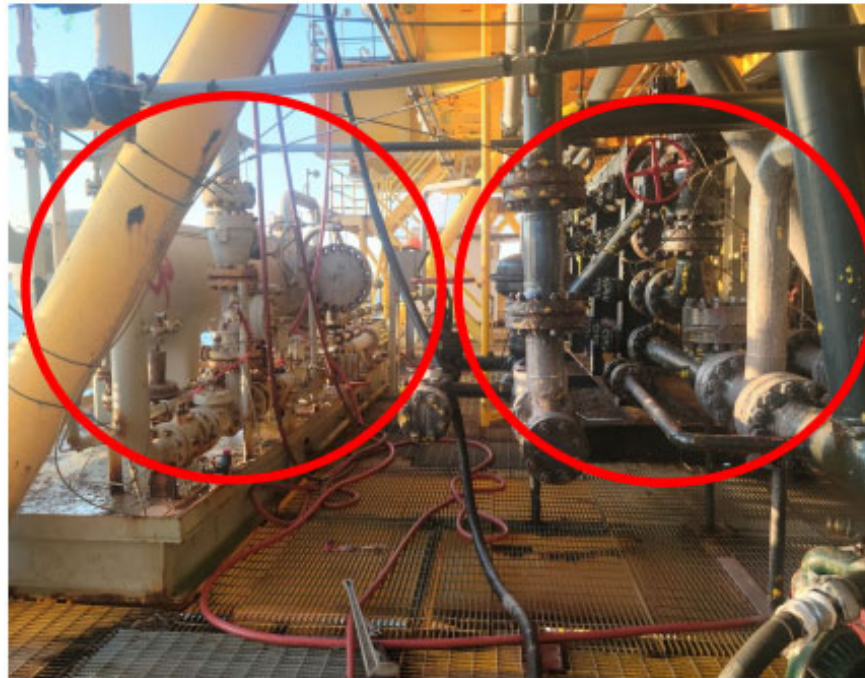
Header and Separator

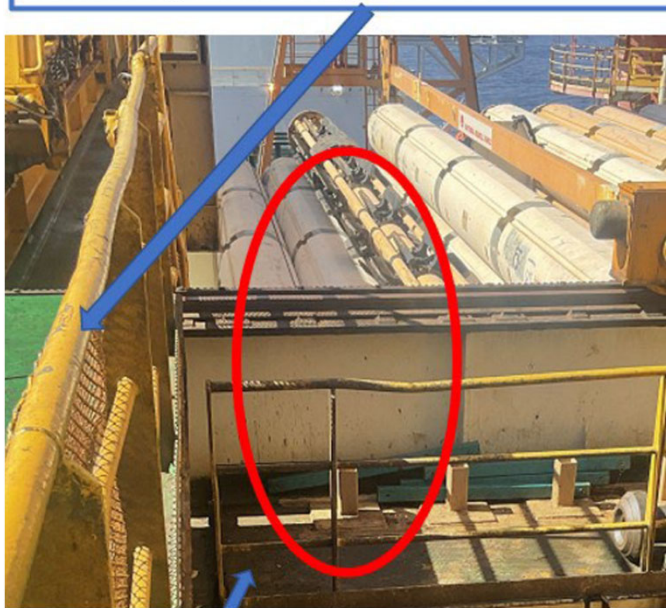
HIPO LIFTING – 6/12/23

Riser Bridge was Being Lowered.

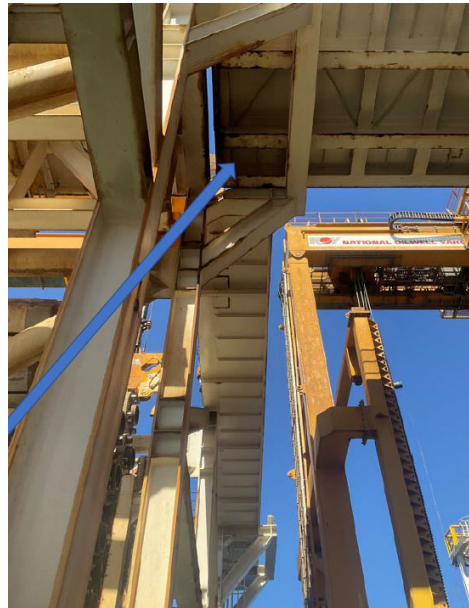
Location of Port Stairs when they were tipped

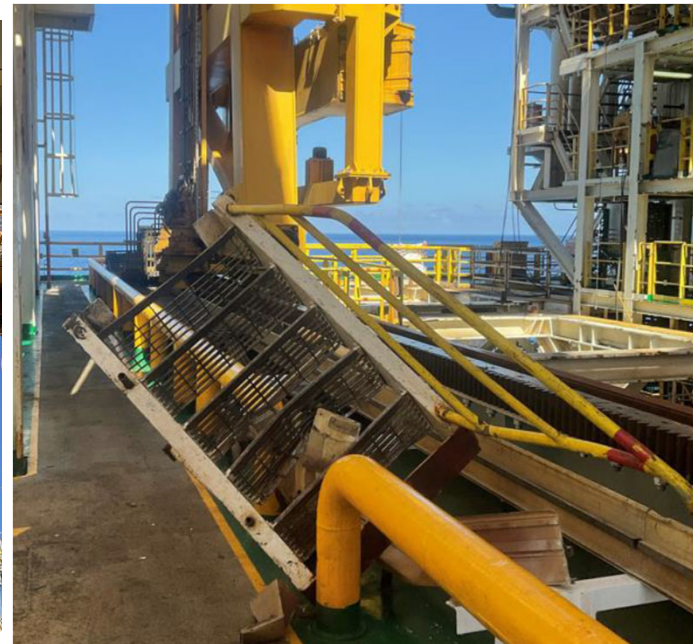
The bridge was not installed at the time of the drop. The bridge was being installed. The stairs were tipped and fell through this location 43 ft to the riser deck below

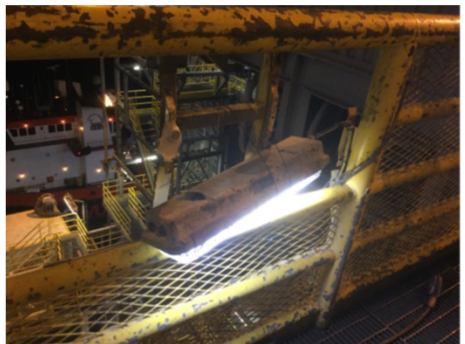
Damage to 16" casing

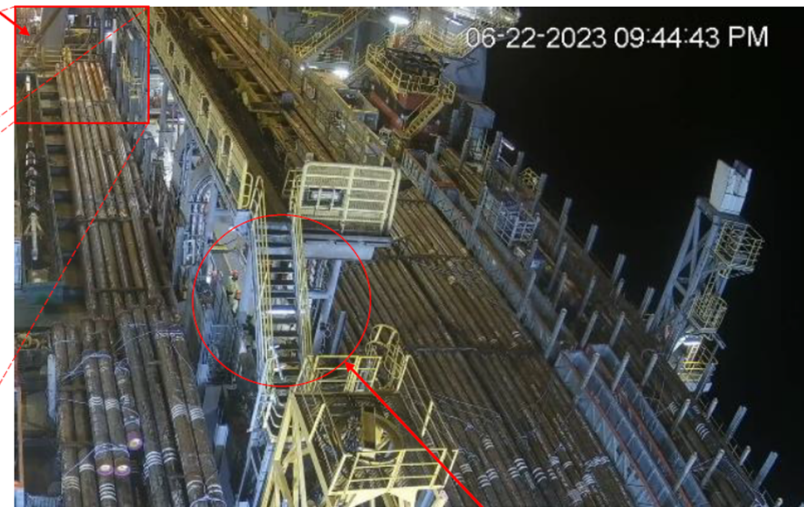
16" double impacting aft pipe deck handrail

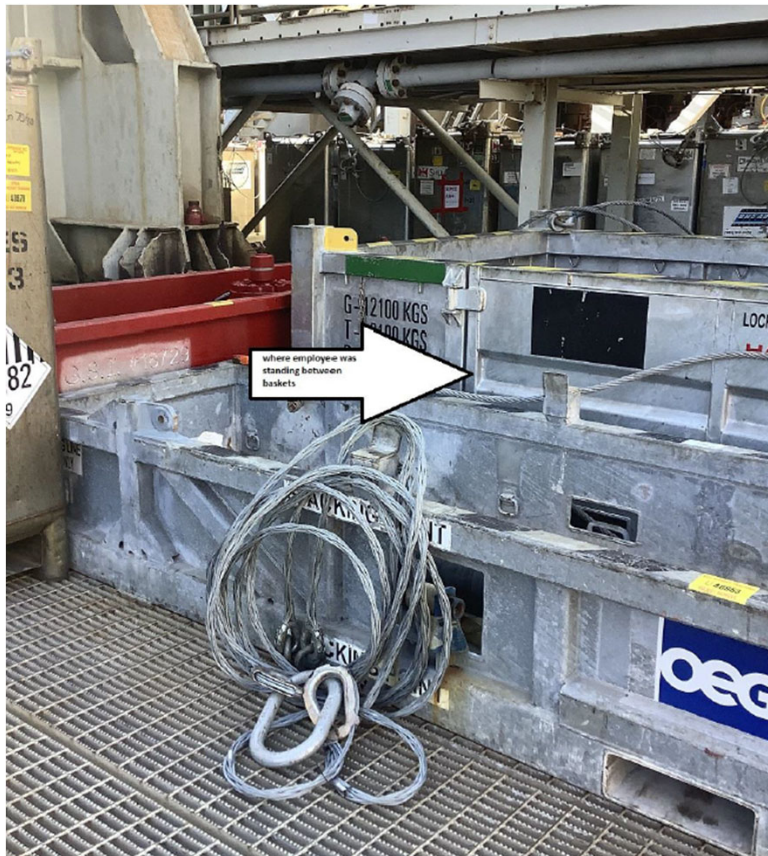
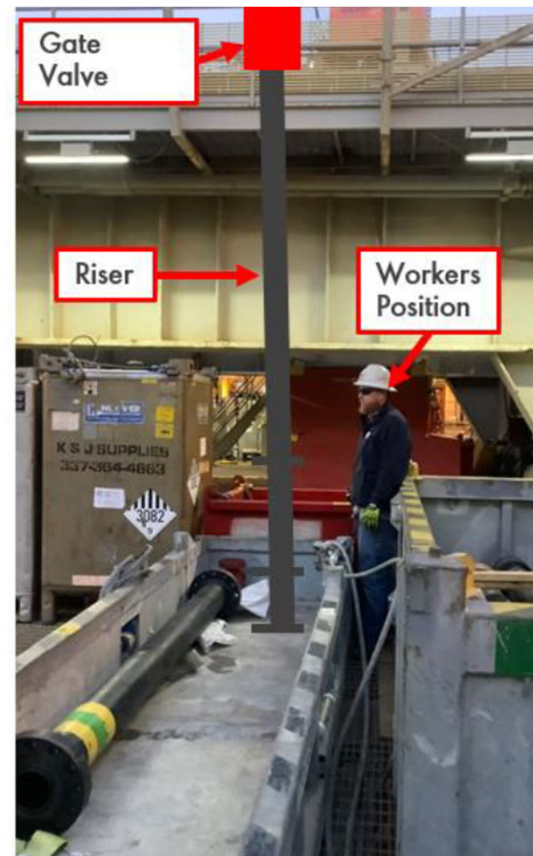
RECENTLY COMPLETED 2010 INVESTIGATION

- This is a High Potential Incident which lead to the IP sustaining multiple injuries – L4 Fracture, Traumatic Hernia, and Pelvic Muscle Tears
- Probable Cause: Congested workspace, where baskets were positioned closely together leaving no space to work around increasing the potential for a pinch point or crushing event
- Contributing Cause: Designated Signaling Person did not identify and communicate to crane operator that rigger was in a pinch point and in danger of injury
