INCIDENT TRENDS – 2023Q3

OCS - GULF OF MEXICO

RFO - Office of Safety Management

8 November 2023

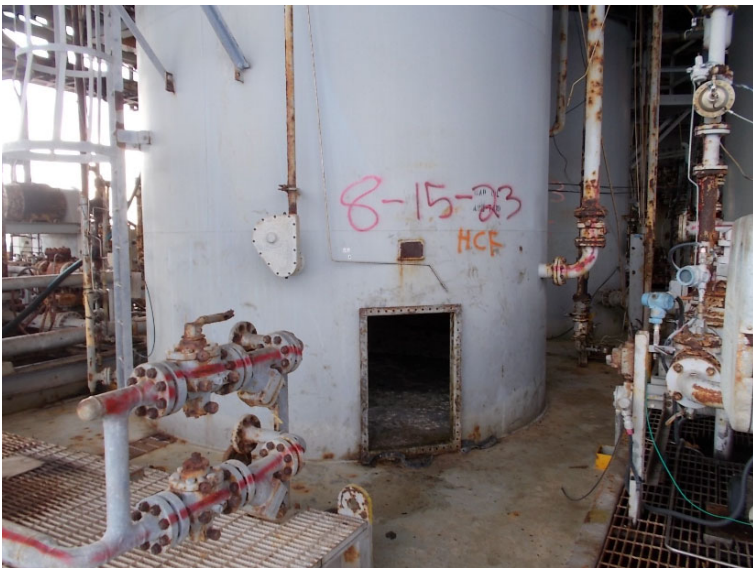
HIPO INJURY, 8/24/2023

At approximately 1630 hours I was contacted via radio by superintendent [REDACTED] for a medical emergency on the production deck. He advised to come off the stairs and make right toward the southwest side of the platform. Pt found sitting just outside of a confined space area. There was a hydrocarbon smell in the vicinity. Pt presents as alert, but slow to answer questions and sweating profusely. The pt advised he is not sure what happened. Pt denies any pain or other symptoms. His coworker [REDACTED] advised the pt had collapsed and when he didn't respond to him, he began CPR compressions. 4 compressions in total were given to the pt and then the pt woke up. When I inquired [REDACTED] confirmed that he did hear a pop noise on the last compression. Coworkers advised LEL readings of 22ppm. Pt advised he was able to ambulate. Pt assisted out of the work area and to a climate-controlled break room for continued pt assessment. Pt vitals unremarkable. Oxygen saturation 99%, heartrate in the 70's NSR. The more time that passed pt was able to answer questions easier. Pt advised he was working when he

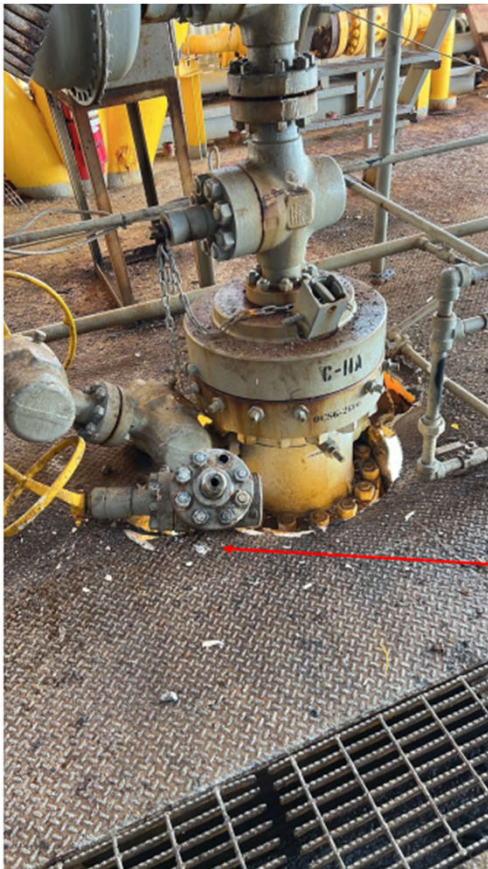
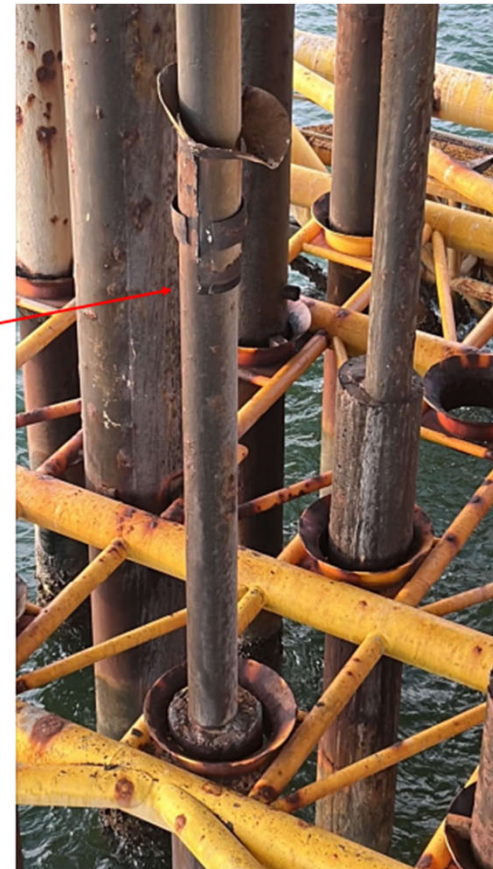
GAS RELEASE– 09/09/2023 GAS RELEASE

Damaged Csg Valve

13-3/8 Conductor
Failure point

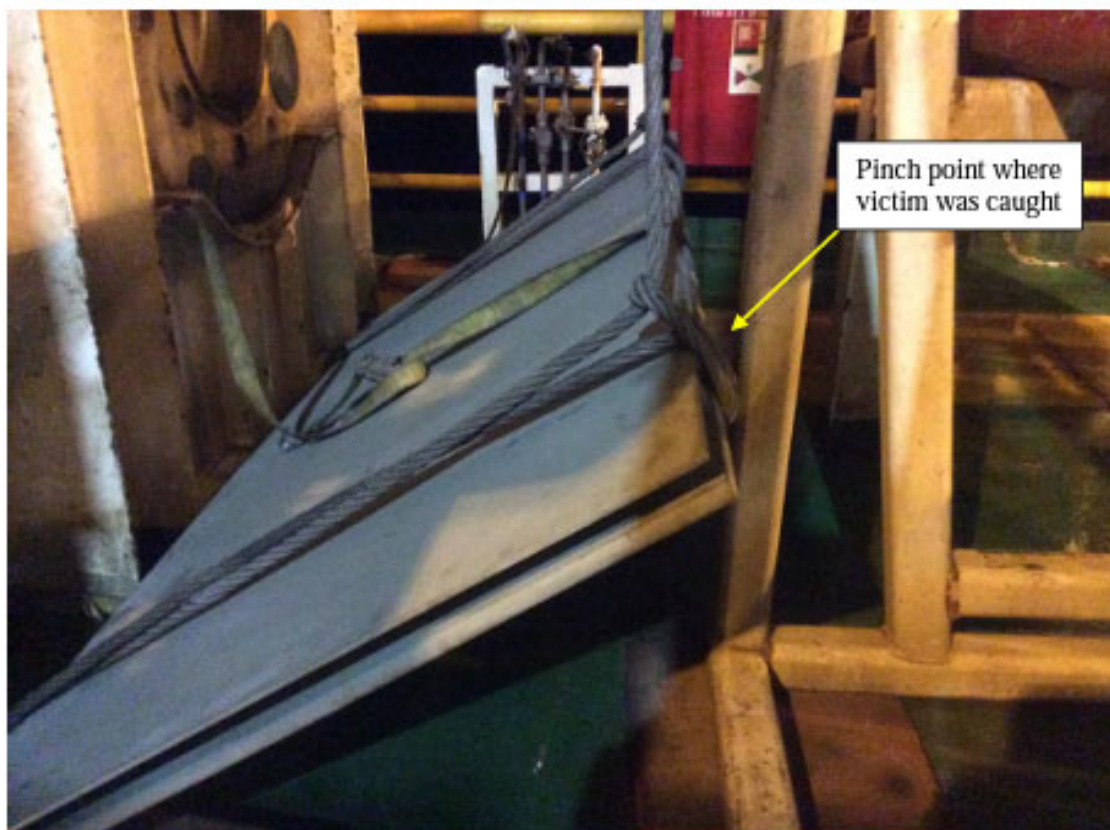
Figure 9 - Position of steel plates against vertical steel post

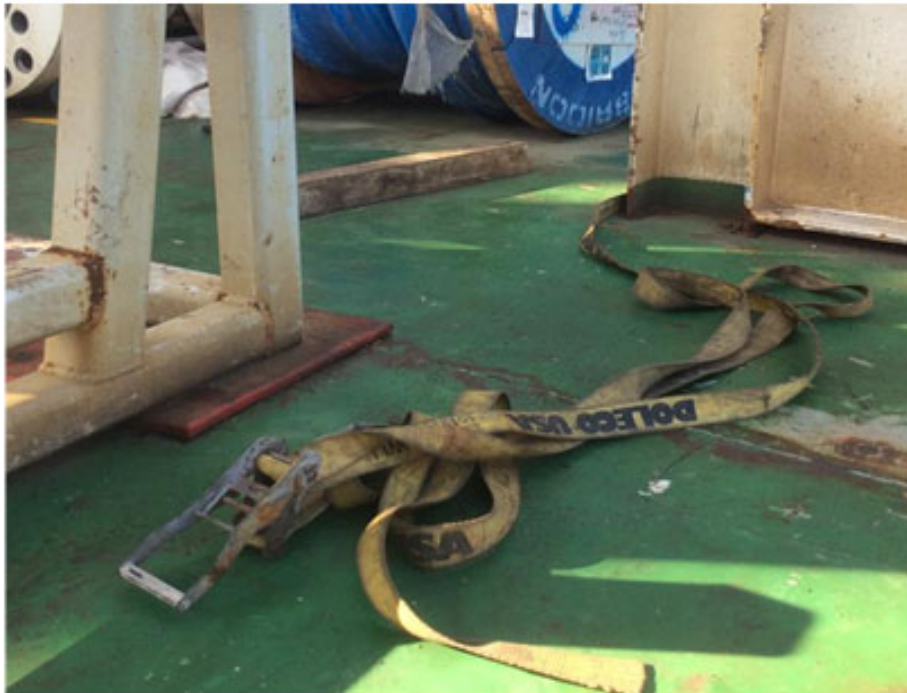
Figure 6 - Ratchet Strap that held the steel plates up against the stanchion beams
