# Aviation Investigation Final Report

| <b>Location:</b> | Galliano, Louisiana | <b>Accident Number:</b> | CEN23FA071 |
| <b>Aircraft:</b> | Bell 407 | <b>Aircraft Damage:</b> | Substantial |
| <b>Defining Event:</b> | Dynamic rollover | <b>Injuries:</b> | 4 Fatal |

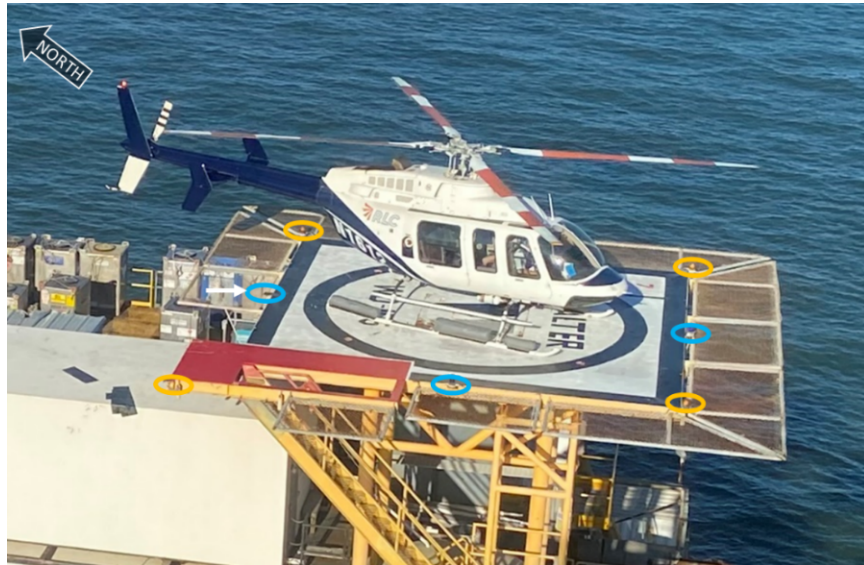
The helideck perimeter lights were 2 inches higher than the construction standard of 6 inches. However, because the helicopter's right skid was already in contact with the perimeter light before the takeoff, the out-of-compliance height of the perimeter light, by itself, did not contribute to dynamic rollover.

The helideck was outlined with eight lights of alternating amber and blue color. The light assemblies were guarded, with no exposed wiring, and were located outboard of the flight deck. The light assemblies, whose attachment hardware to the helideck were not frangible, measured about 8 inches tall. The helideck deck was painted white with a black border. A 10-ft-diameter black aiming circle was painted in the center of the helideck. The words "WALTER" and "WD-106" were painted inside the aiming circle, along with a painted gray and black "W" icon. The stairwell for the helideck was in the southwest elevation and had a red border around it. A metal perimeter safety skirting outlined the helideck. Except for the eight perimeter light assemblies, no objects were elevated or stood proud on the helideck, as shown in Figure 1.

**Figure 1.** Photo of an exemplar Bell 407 helicopter on the WD-106 helideck.

**Note:** Helideck perimeter amber lights are circled in amber, and perimeter blue lights are circled in blue. The white arrow points to the light significant to the accident.

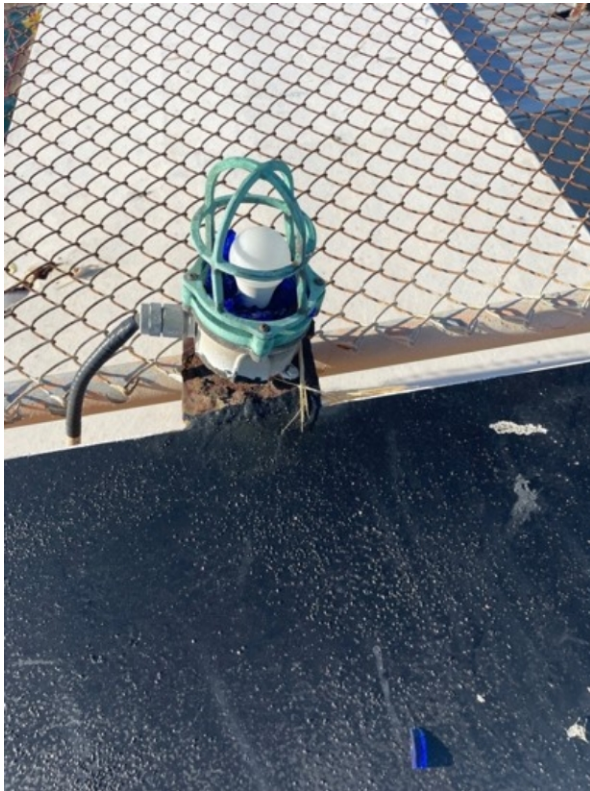
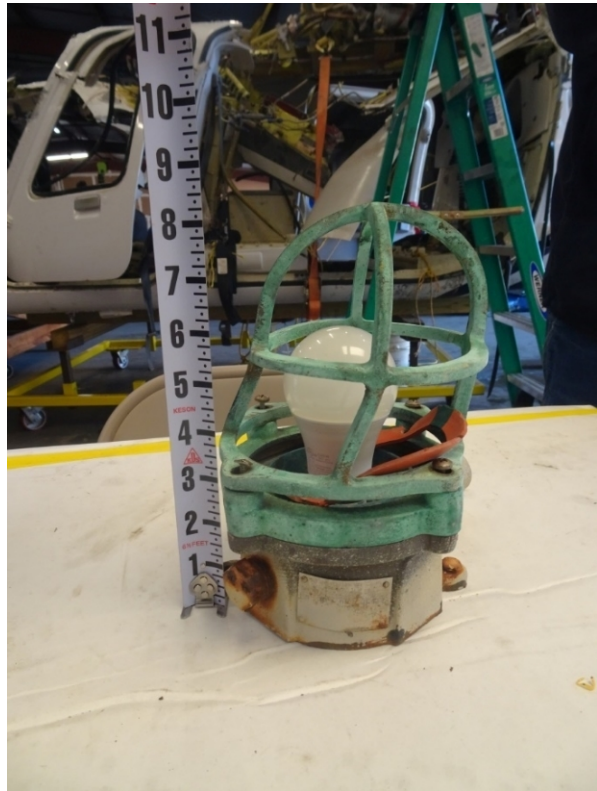
Further examination of the helideck revealed that the center blue light assembly on the northwest elevation of the helideck was damaged but still attached to its 6 inch by 6 inch light mount. Although the light remained installed on the mount, its blue glass globe was fragmented and the metal protective guard for the globe was significantly deformed and bent toward the stairwell, as shown in Figure 2. After the accident, a platform employee removed the damaged light assembly from the mount out of concern for safety during future use of the helideck. The amber light, located on the west corner of the helideck, near the stairwell, separated from its mount and was not recovered. The remaining perimeter lights appeared undamaged.

**Figure 2.** Photo (left) of the damaged center perimeter light shortly after the accident (Source: Walter Oil and Gas). Photo (right) of the same light assembly after it was removed from the helideck (Source: NTSB).

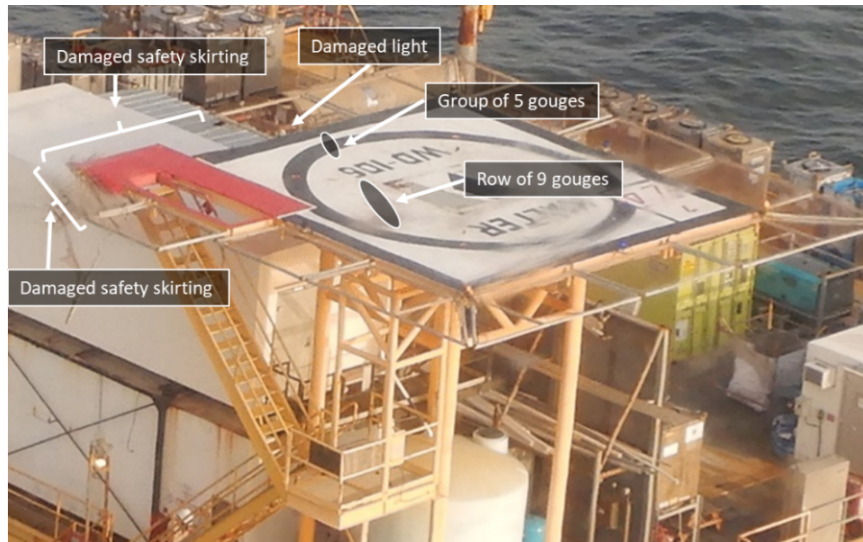
Two areas of gouges in the paint on the helideck were present. The first area was a row of nine irregularly spaced but inline gouges, as depicted in Figure 3, located inside the aiming circle and adjacent to the "W" icon logo painted on the helideck. The second area was a group of five irregularly spaced gouges, found in the black paint of the aiming circle, near the northeast side and near the damaged center light. Figure 4 is an illustration showing the location of the two areas of paint gouges and the damaged light assembly.

**Figure 3.** Image identifying some of the damage to the helideck.

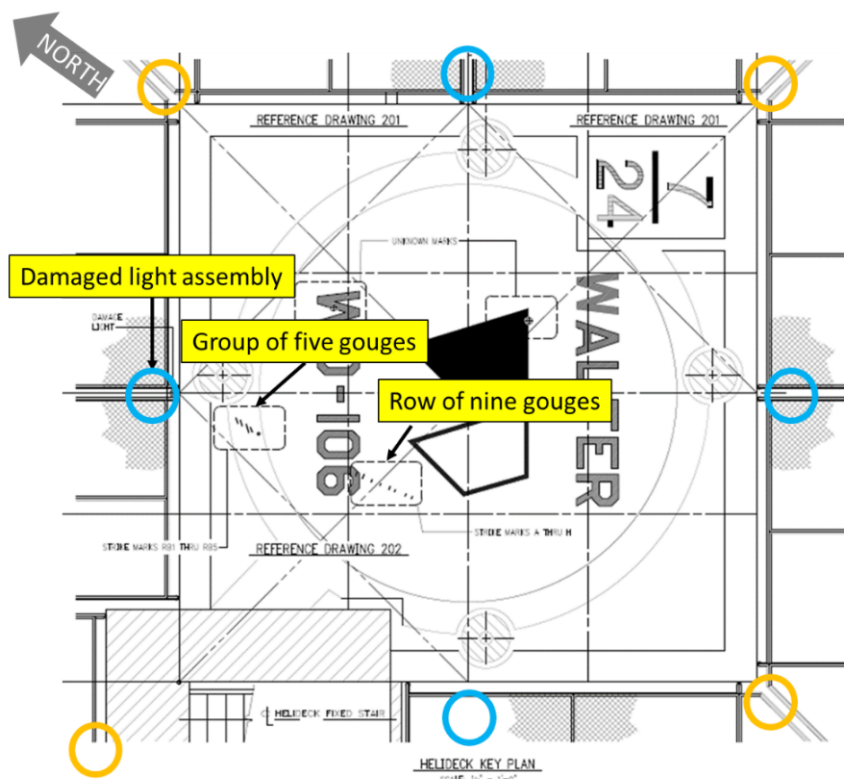
**Figure 4.** Illustration depicting the location of the two groups of gouges in the helideck paint and the location of the damaged perimeter light assembly.

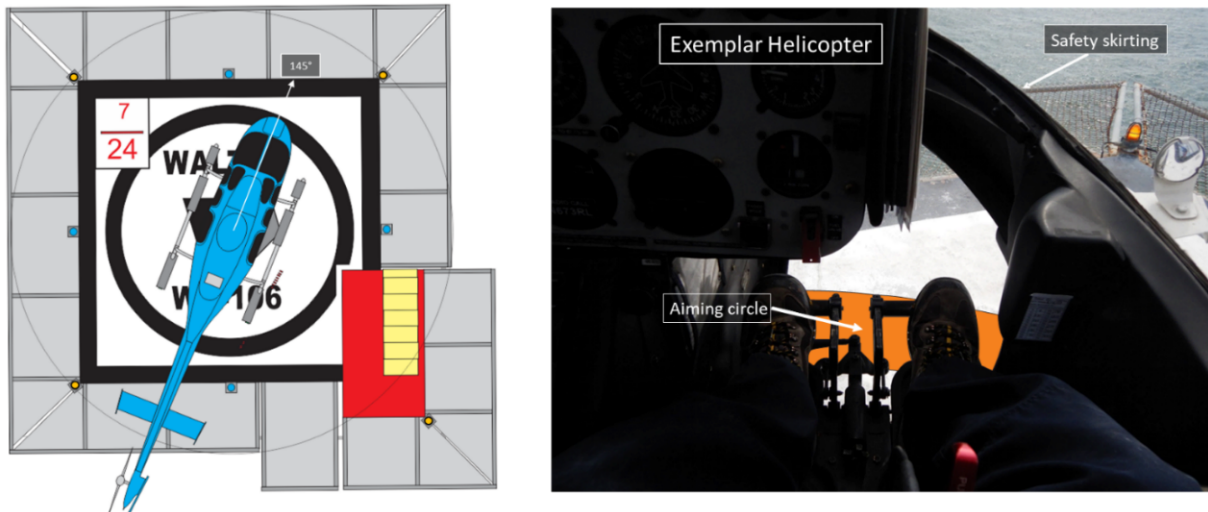
**Figure 5.** Photo (right) captured while the exemplar helicopter was in the center of the aiming circle and showing the right-side chin bubble and the location of the aiming circle, highlighted in orange, under the anti-torque pedals. The illustration (left) depicts the exemplar helicopter's position and orientation on the helideck.

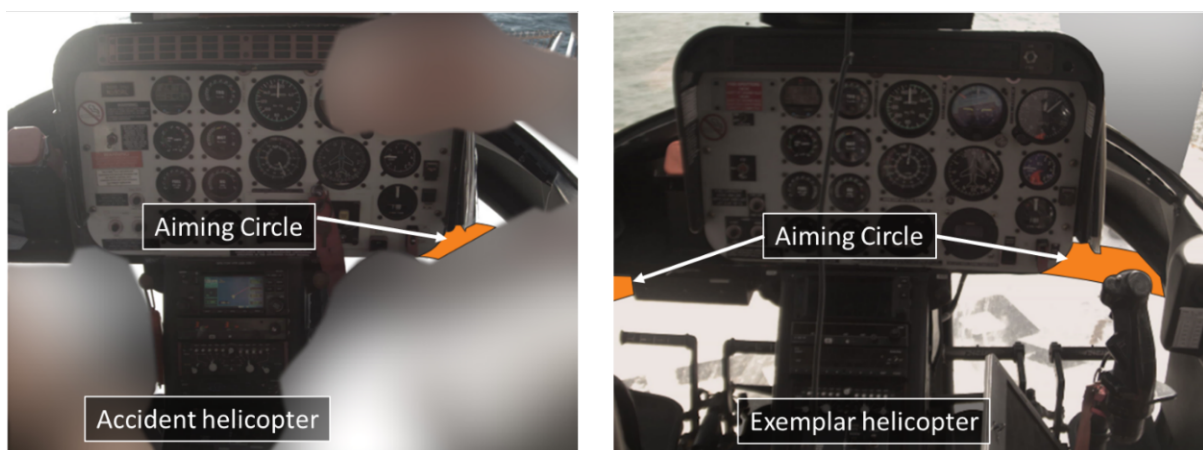
The exemplar helicopter was then repositioned straight aft on the helideck to match the accident recorder's FOV before the takeoff, as shown in Figure 6.

**Figure 6.** Side-by-side comparison of the accident helicopter's Appareo FOV (left) and the exemplar helicopter's Appareo FOV (right). Aiming circles are highlighted in orange.

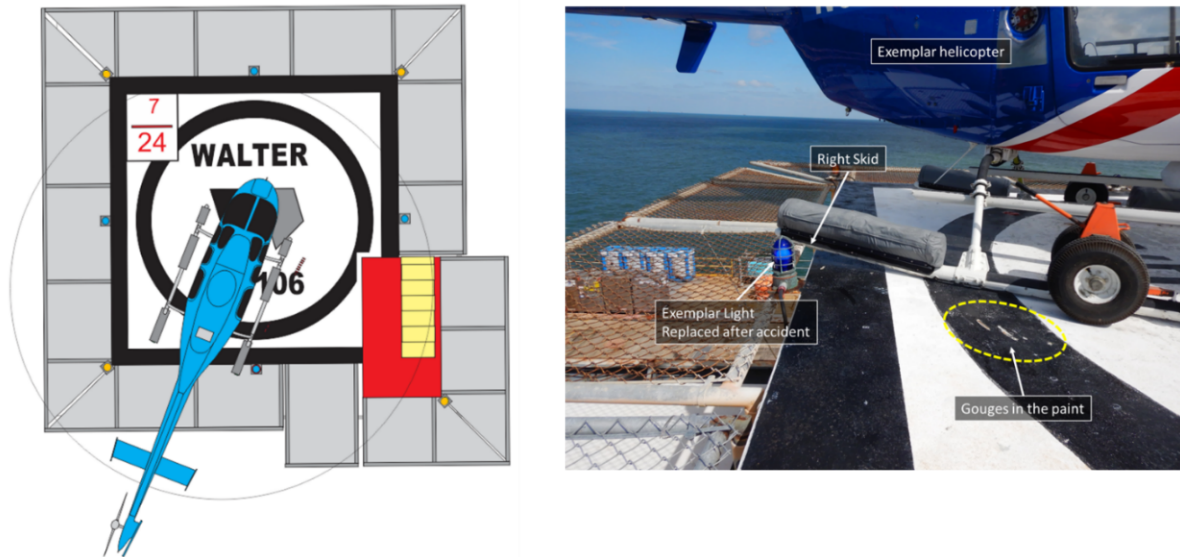
Moving the exemplar helicopter straight aft to match the accident FOV resulted in the right skid extending past the edge of the helideck, while the left skid remained completely on the helideck, as shown in Figure 7.

**Figure 7.** Photo (right) showing the aft section of the exemplar helicopter's right skid beyond the edge of the northwest side of the helideck. The illustration (left) depicts the exemplar helicopter's location on the helideck.

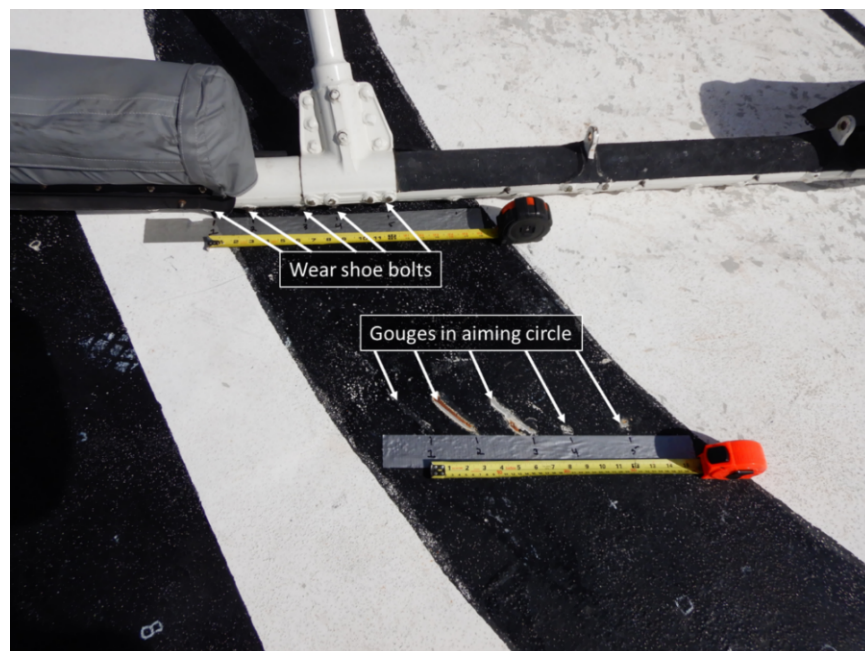
When compared to the group of five gouges in the aiming circle, the exemplar helicopter's five wear shoe mounting bolts were near the gouges and matched the spacing between the gouges, as shown in Figure 8.

**Figure 8.** Photo of an exemplar helicopter's right skid showing the five wear shoe mounting bolts that matched the spacing of the group of five irregularly spaced gouges in the helideck paint.

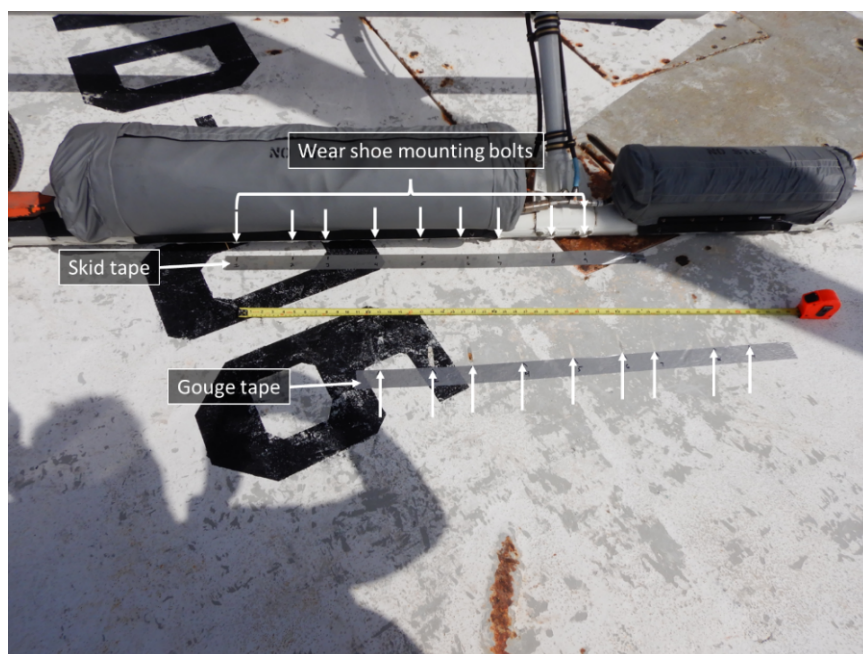
With the exemplar helicopter still in the position that matched the accident helicopter's FOV, the middle section of the right skid was compared to the row of nine irregularly spaced but inline gouges to the helideck paint. A section of nine wear shoe mounting bolts were near the gouges and matched the spacing of the gouges, as shown in Figure 9.

**Figure 9.** Photo showing the row of nine irregularly spaced but inline gouges in the paint alongside the matching wear shoe mounting hardware.
