Blue color representing primary barrier
Red color representing secondary barrier

Reservations are made on detail correctness as this is made on limited public information

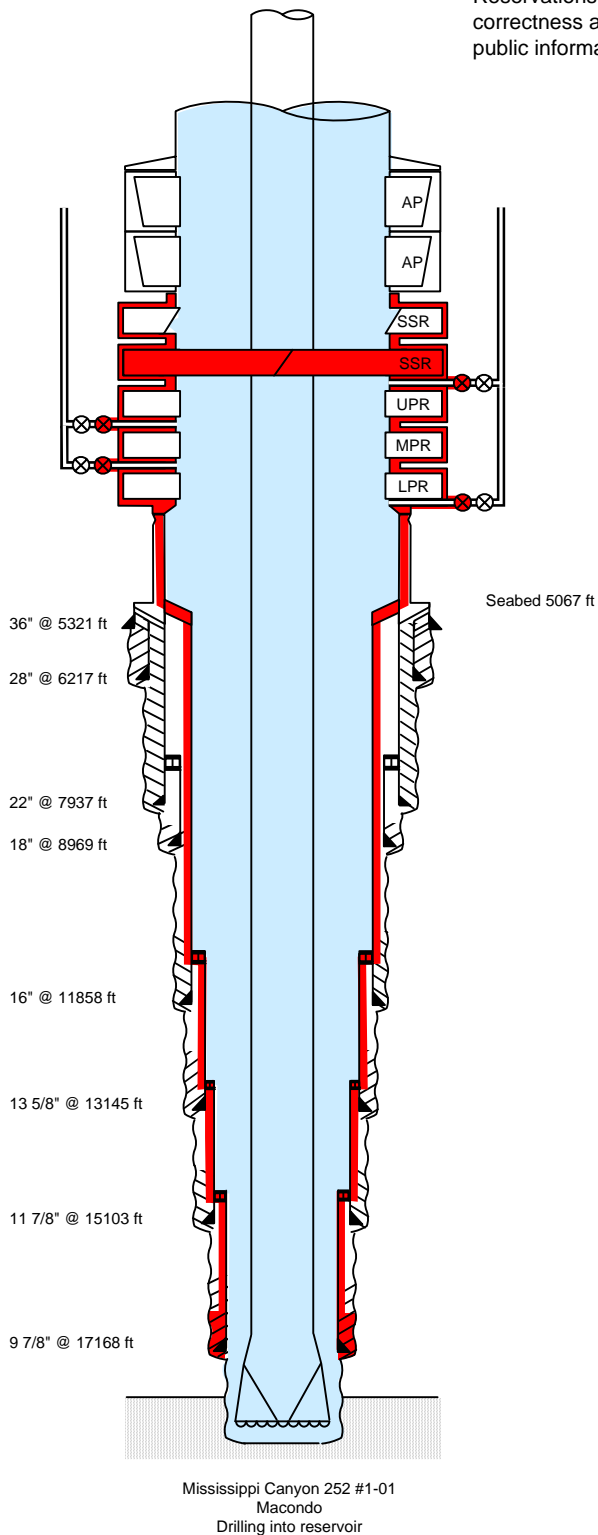
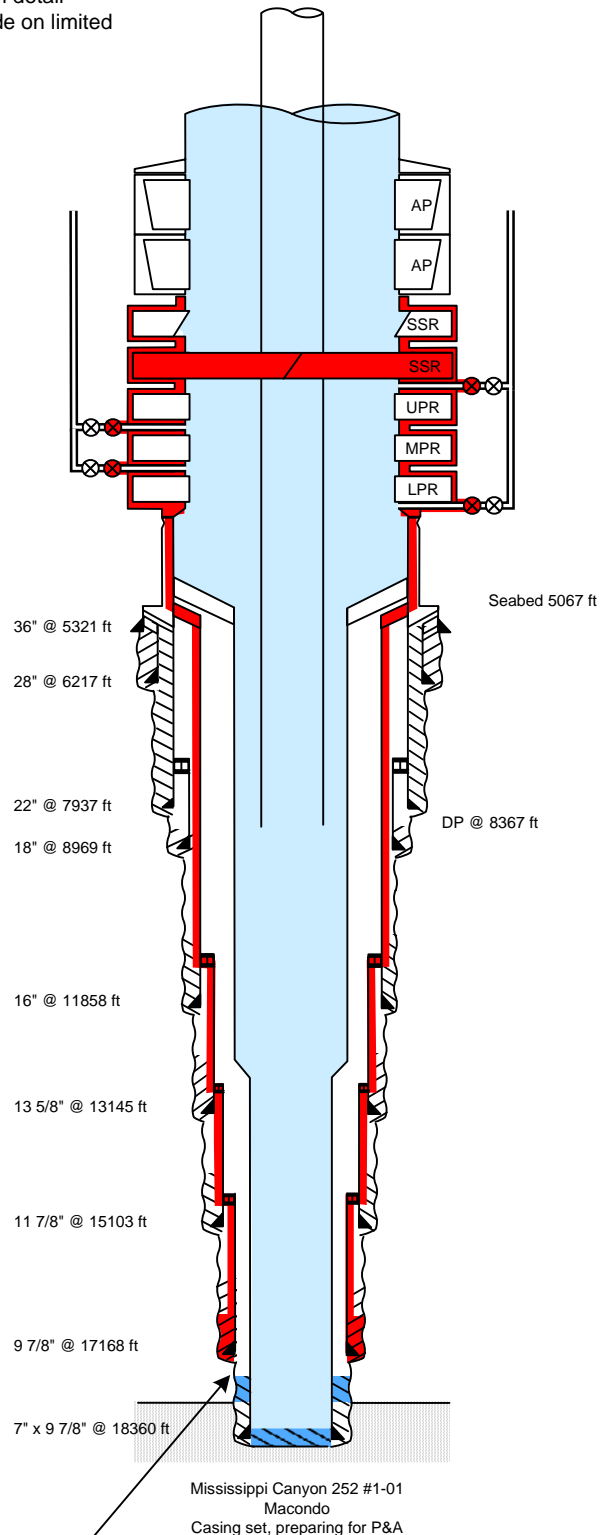
This is a vulnerable section of the well.
If the cement above the cap rock is not good there will be a channel travelling all the way to the well head exposing the 16" casing and the 9 7/8" hanger seal assembly.
