SAFETY ALERT

Safety Alert No. 444

Floorman Falls Off Derrick Ladder

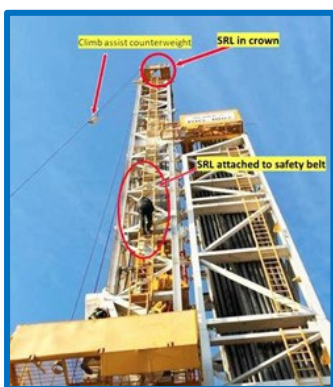
Incident 1: The company provided a photo of an employee using an SRL, as required by its policy.

- The Job Safety Environmental Analysis (JSEA) did not address ascending and descending the derrick ladder.
- The employee incorrectly used a hook and release method of using double lanyards to attach to the rungs of the ladders instead of using a self-retracting lifeline as required by the operator's/contractor's policies and procedures.
- Employee exhaustion might have been a contributing causal factor.
- Improvements need to be made to its fall protection policies and procedures.
- Improvements need to be made to its fall protection equipment.
- Improvements need to be made to its "working at heights" training and competency for new personnel.

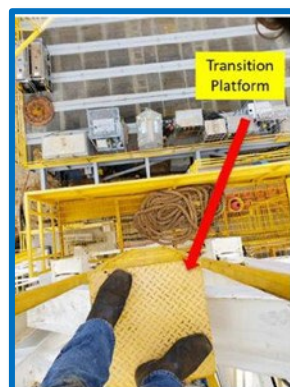
Figure 2: Transition where IP fell.

was tasked to climb up to check and correct the plugs to ensure they were connected. Once completed, the IP descended the derrick ladder until he came to a transition platform. While transitioning to the lower ladder, the IP fell approximately 11 feet to the walk-around platform below. The IP was wearing a fall protection harness with a double hook lanyard. The IP was not tied off at the time of the fall. The A-frame walkway kept the IP from falling an additional 30 feet, which would have caused further injury or death.

The company's incident investigation revealed the IP was using a hook and release process setup with double lanyards to stay securely attached to the rungs of the ladders. At the transition point between the upper and lower ladders, a failure to remain tied off occurred, allowing for the employee to fall. Additionally, the company found that:

- Review all "working at heights" policies and procedures to ensure they are adequate and are being followed.
- Ensure rescue personnel are identified and Emergency Rescue Plans are completed and discussed before operations begin.
- Inspect all work areas to determine if there are any gaps where employees have difficulty maintaining 100% tie-off while transitioning from one ladder section to another.
- Consider installing a rail or cable fall arrest system directly onto ladders to further mitigate the hazards associated with working at heights. Ensure the fall arrest system extends above the top of the ladder so the worker will have something to hold on to before descending.

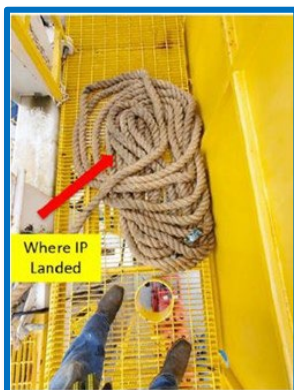
Figure 3: The lower platform where IP landed.

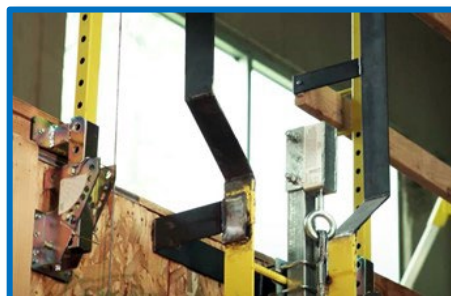
Figure 4: Fall arrest system extending above the top of the ladder for worker to hold on to.
