GOMR Incident Trends

Jason P. Mathews

Chief, Office of Safety Management
Gulf of Mexico Region

June 7, 2022

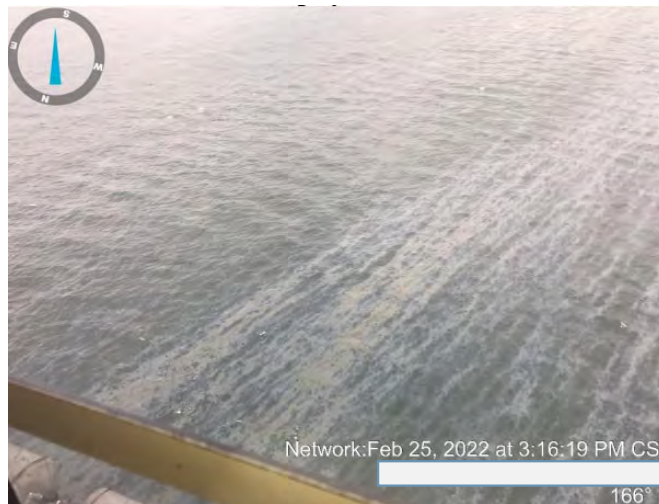
Spill >1 bbl – 2/25/22

- An estimate of 111 gallons of unrecoverable oil was discharged into the Gulf of Mexico through the platform's vent boom.
