INCIDENT TRENDS – 2023Q2

OCS - GULF OF MEXICO

RFO - Office of Safety Management

24 August 2023

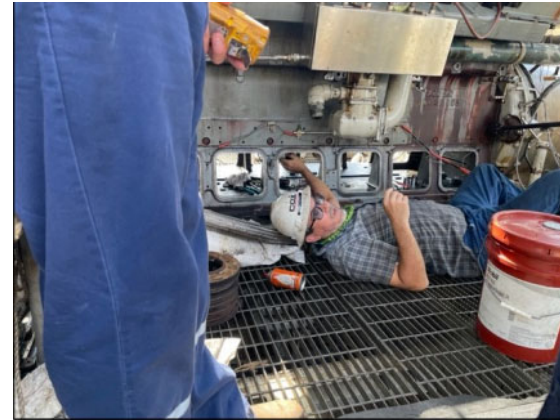
INJURY, LTA>3 – 6/17/23

Description:
Employee's position at time of incident.

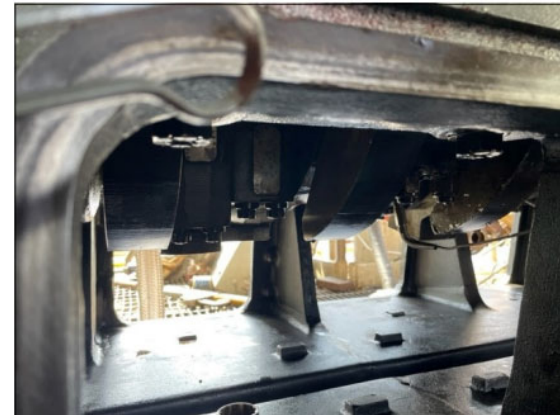
Description:
Side view of compressor block with rod caps.

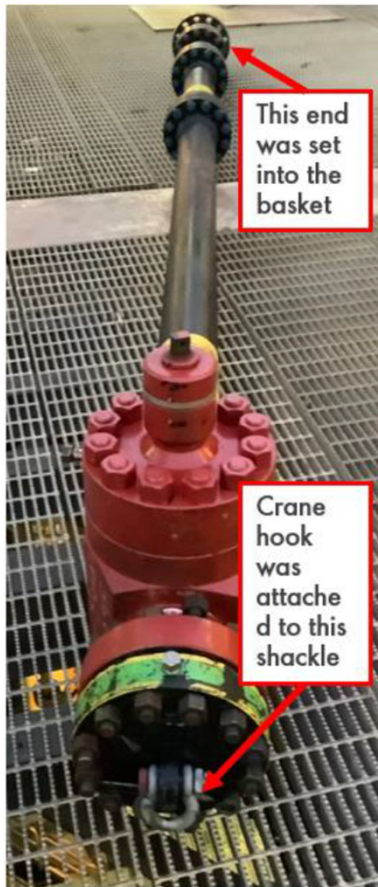
RECENTLY COMPLETED 2010 INVESTIGATION

- This is a High Potential Incident which lead to the IP sustaining multiple injuries – L4 Fracture, Traumatic Hernia, and Pelvic Muscle Tears
- Probable Cause: Congested workspace, where baskets were positioned closely together leaving no space to work around increasing the potential for a pinch point or crushing event
- Contributing Cause: Designated Signaling Person did not identify and communicate to crane operator that rigger was in a pinch point and in danger of injury
